## **AT-S94 Version 3.0.0.44**

### **AT-8000S Switch**

## **Software Release Notes**

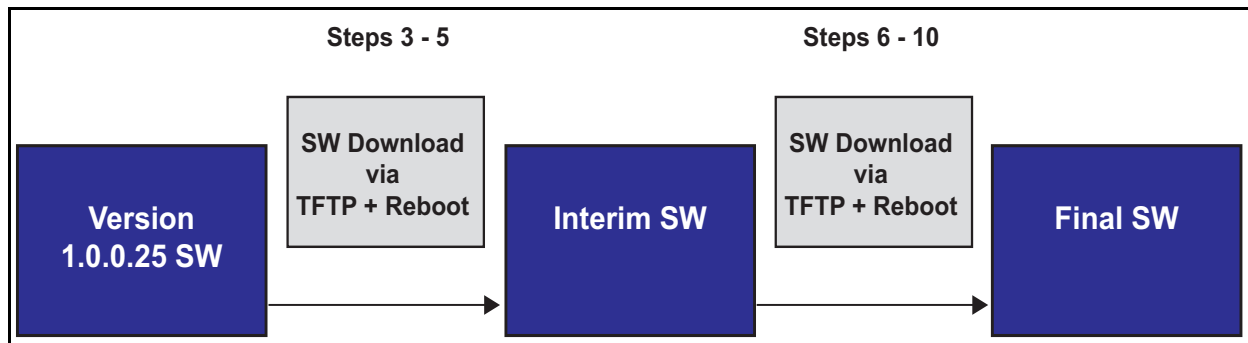
Figure 1. Software Upgrade Process from Version 1.0.0.25

The interim version provided reorders the FLASH allocation without the need to erase the FLASH and download the new software via the serial cable using XMODEM. Hence, the AT-8000S software upgrade procedure can be performed via TFTP server. The block diagram of this procedure is shown in Figure 1.

Due to new Board Support Package (BSP) there is also an updated Boot code: version 1.0.0.7. This can be uploaded regardless of the SW image (ROS version) running on the device. Therefore, boot upgrade can be performed before or after the upgrade procedure described below.

The existing configuration is retained including MAC address and serial number.
